**NBSIR 82-2465**

# **Investigation of the Kansas City Hyatt Regency Walkways Collapse**

U.S. DEPARTMENT OF COMMERCE  
National Bureau of Standards  
Washington, DC 20234

February 1982

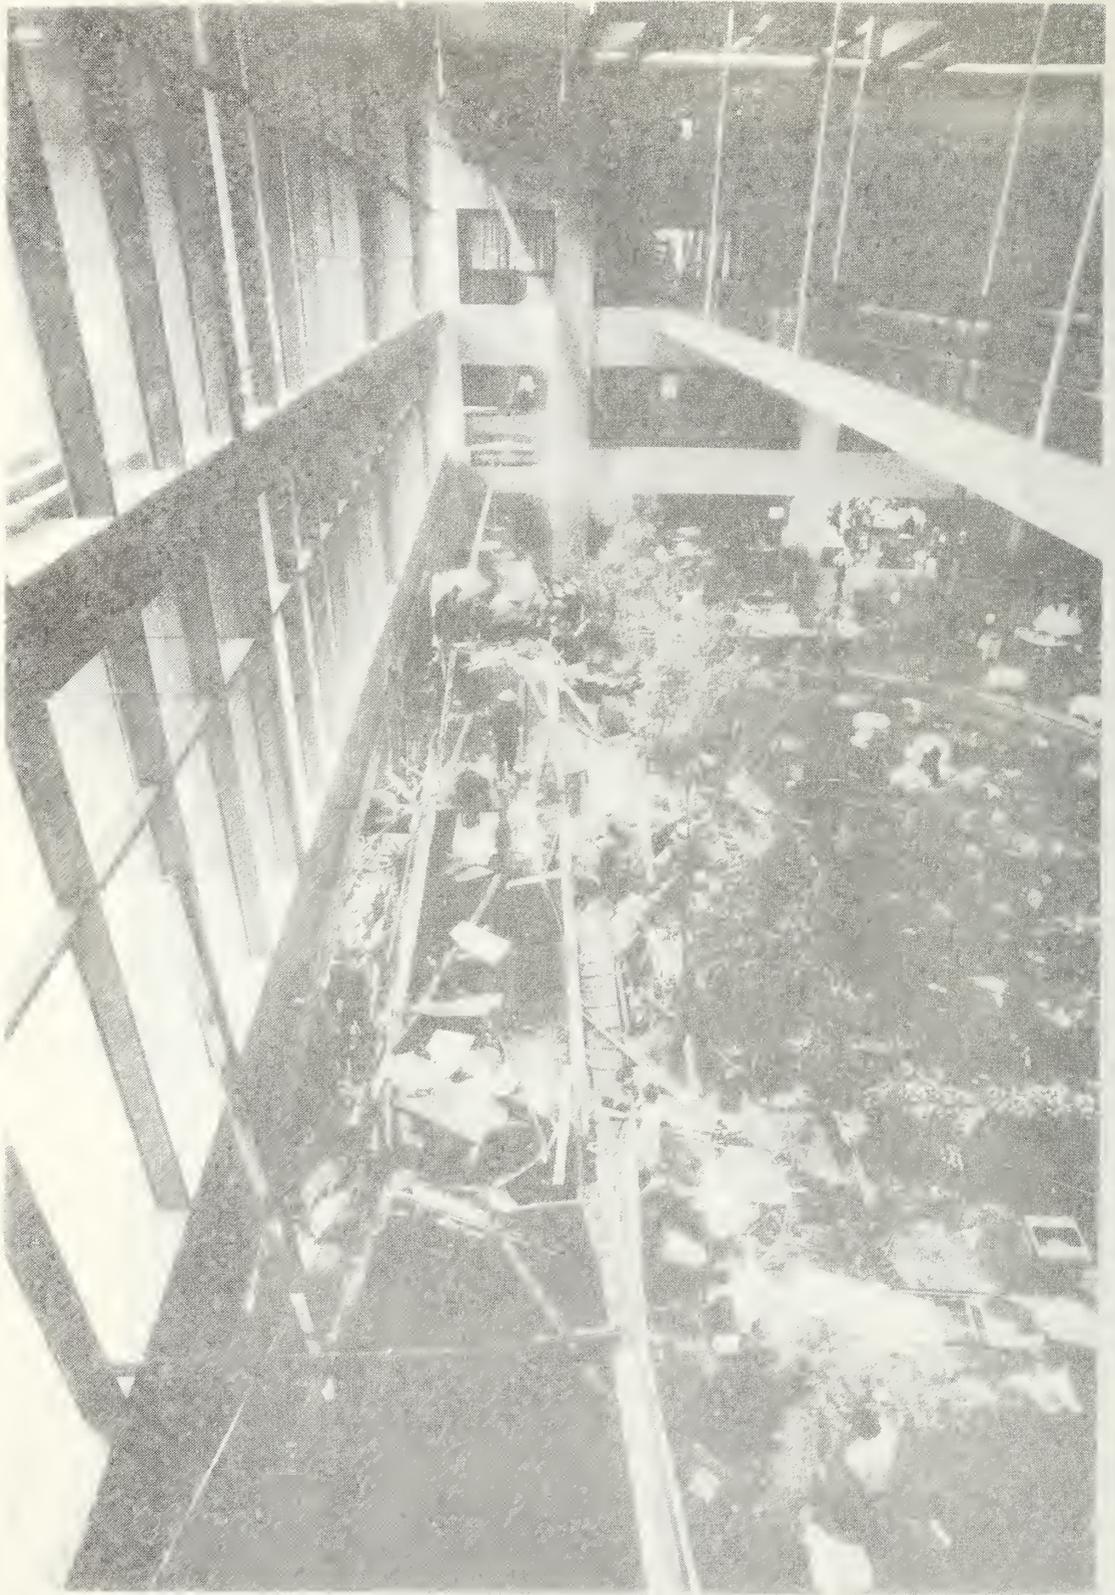
Figure 4.1 Walkways shortly after the collapse. View is to the west-northwest with span U7-8 sloping down and to the right. Spans U8-9 and U9-10 are visible behind the trees. Photo by Greg Smith, reprinted by permission of The Kansas City Times, © 1981, The Kansas City Star Company.

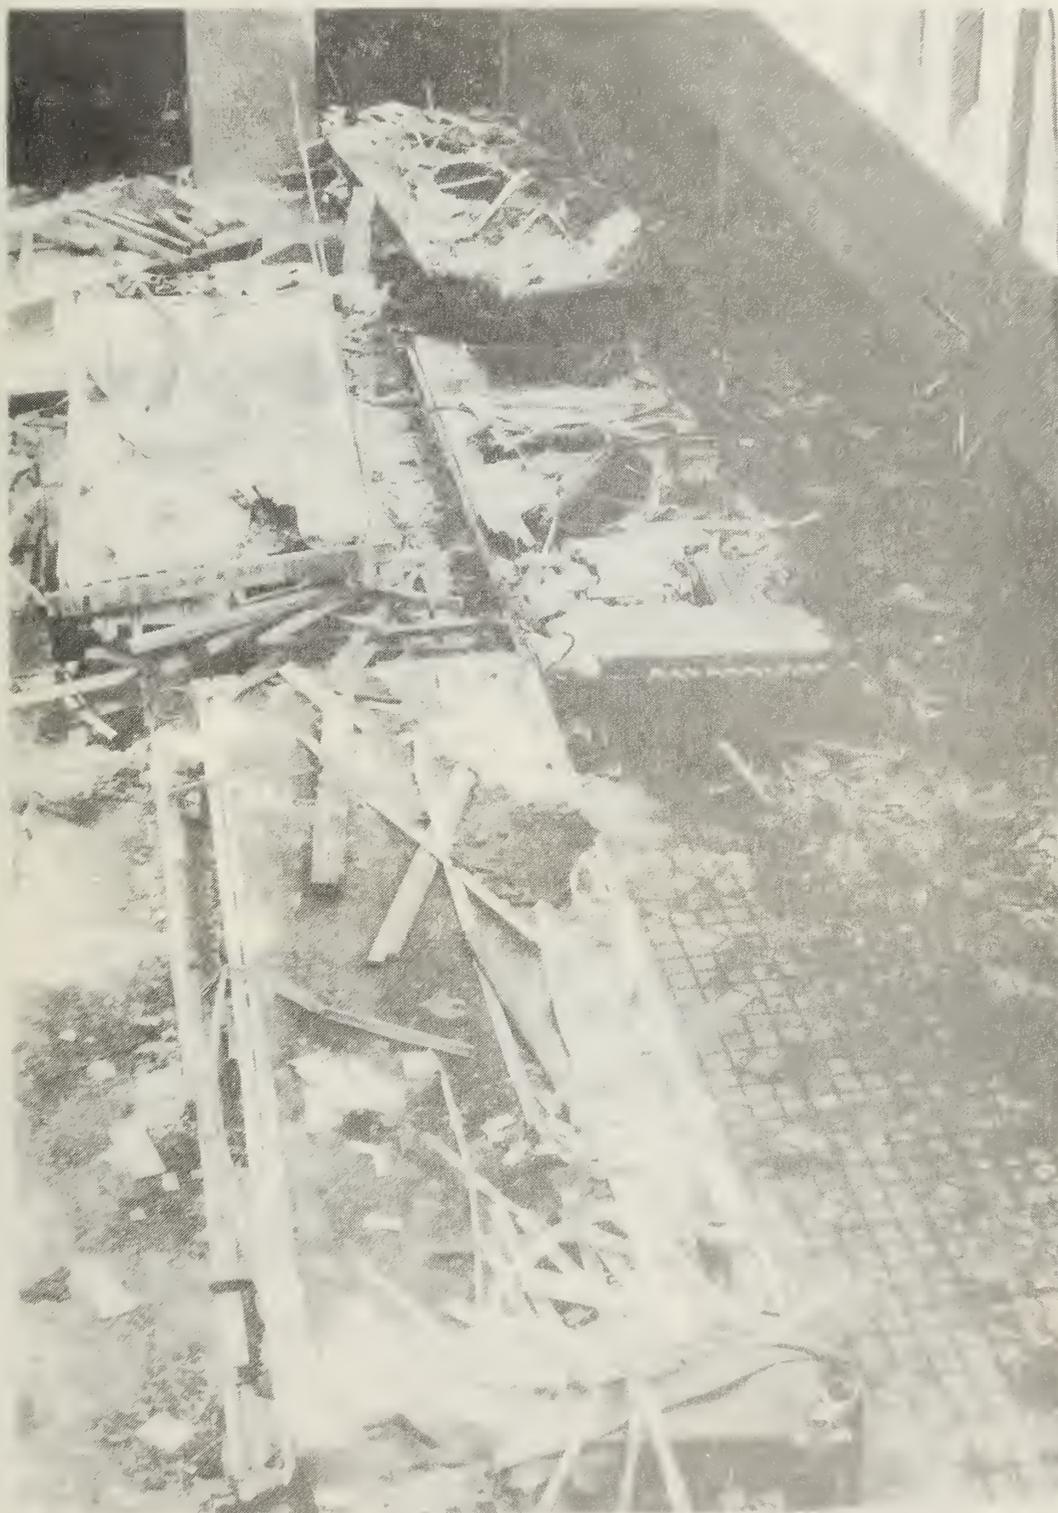
Figure 4.2 Walkways shortly after the collapse. View is directly to the north along the axis of the walkways. Span U7-8 is in foreground and third floor walkway is at upper right. Water is coming from broken sprinkler pipes. Photo by Greg Smith, reprinted by permission of The Kansas City Times, © 1981, The Kansas City Star Company.

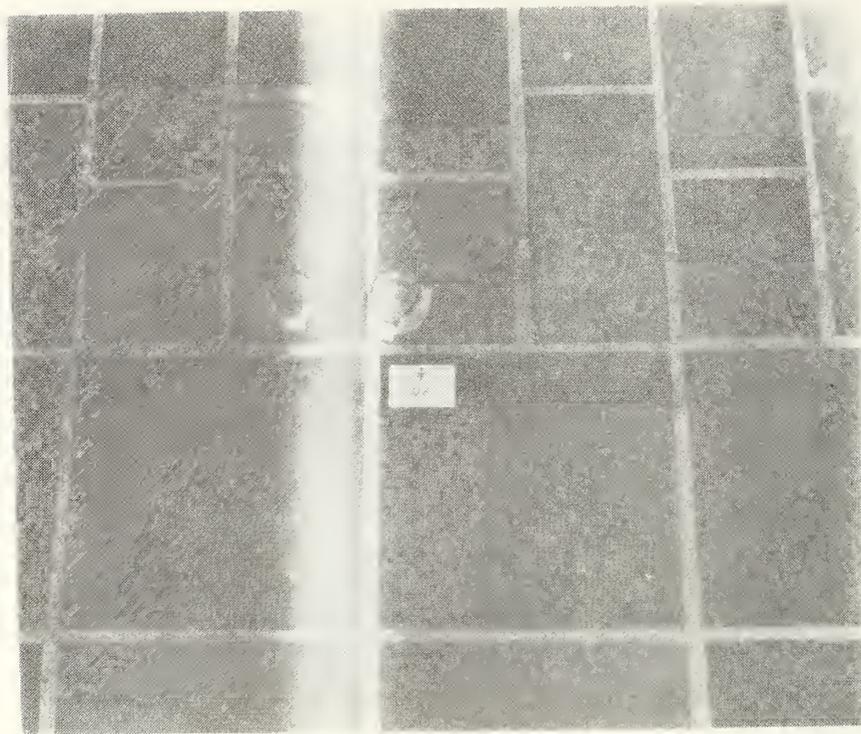
Figure 5.3 Tile damage caused by second floor hanger rod 10E.

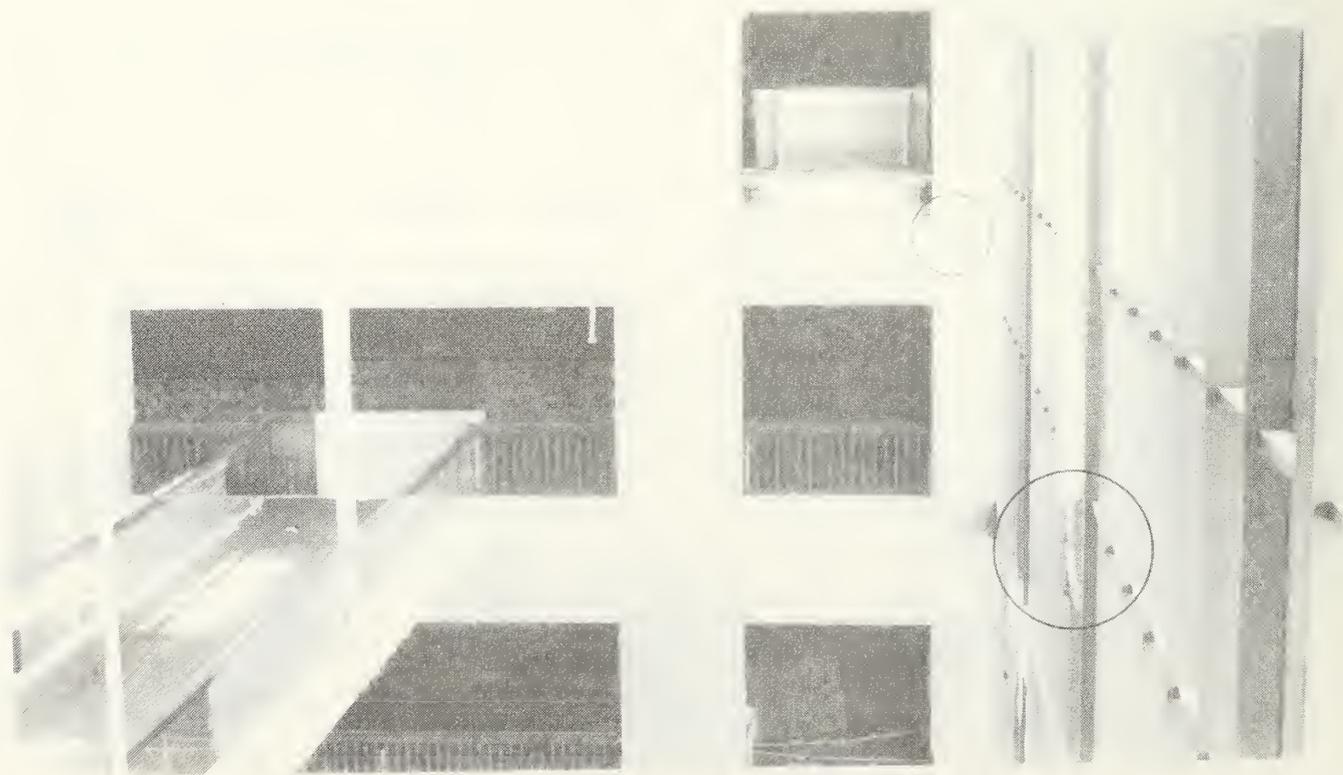
One final observation of importance is the pronounced bend to the west at the bottom end of hanger rod 10UW and a lesser bend at the bottom of hanger rod 8UW as can be seen in figure 5.4. Not apparent in figure 5.4 is a slight bend at the bottom of hanger rod 9UW which was detected after the hanger rods had been removed to the warehouse. The absence of appreciable distortions in hanger rods 8UE, 9UE, and 10UE strongly suggests that failure initiated along the east line of hanger rods.

Figure 5.4 Fourth floor to ceiling hanger rods. View from fourth floor looking south.

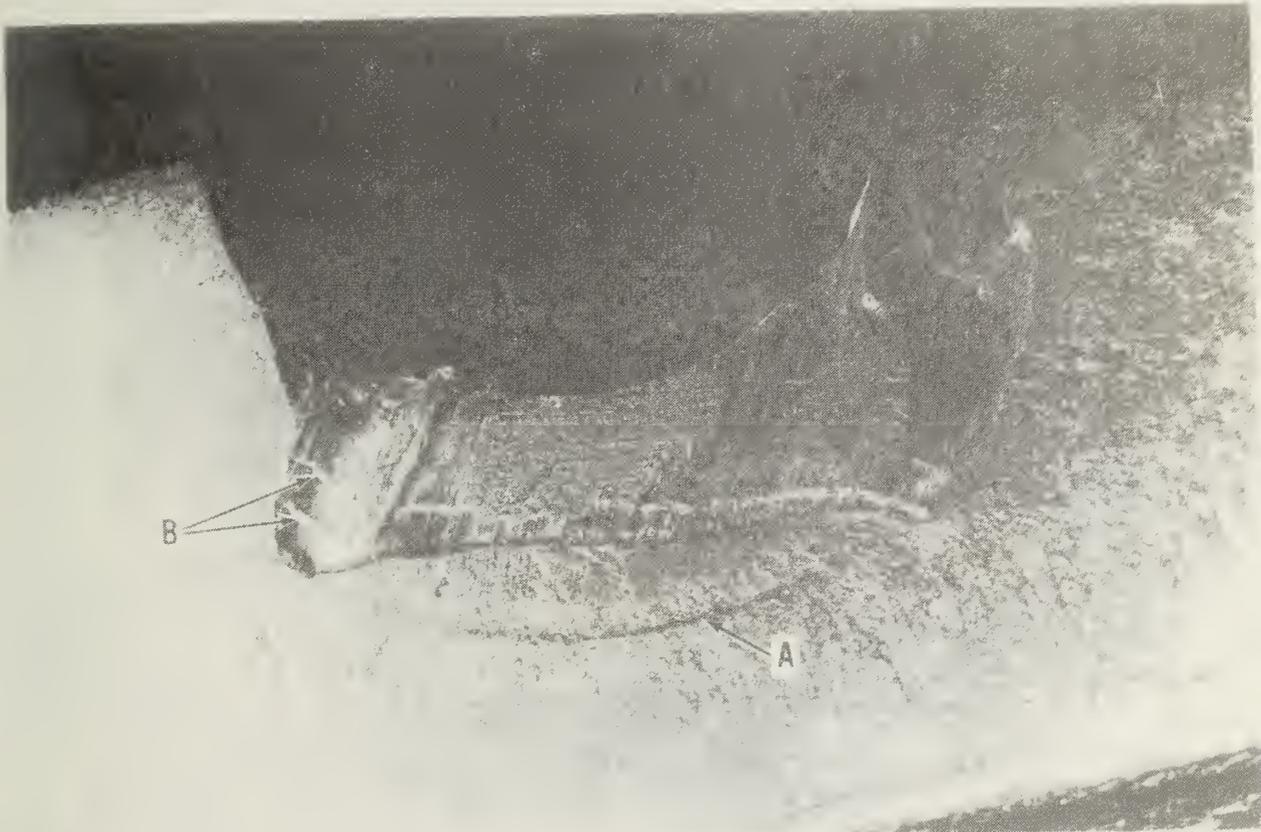
Figure 5.10 Deformation at underside, outer hole, location 9UE due to pull-through of washer/nut assembly. Note imprint of washer (A) and evidence of slip-stick progressive failure (B).

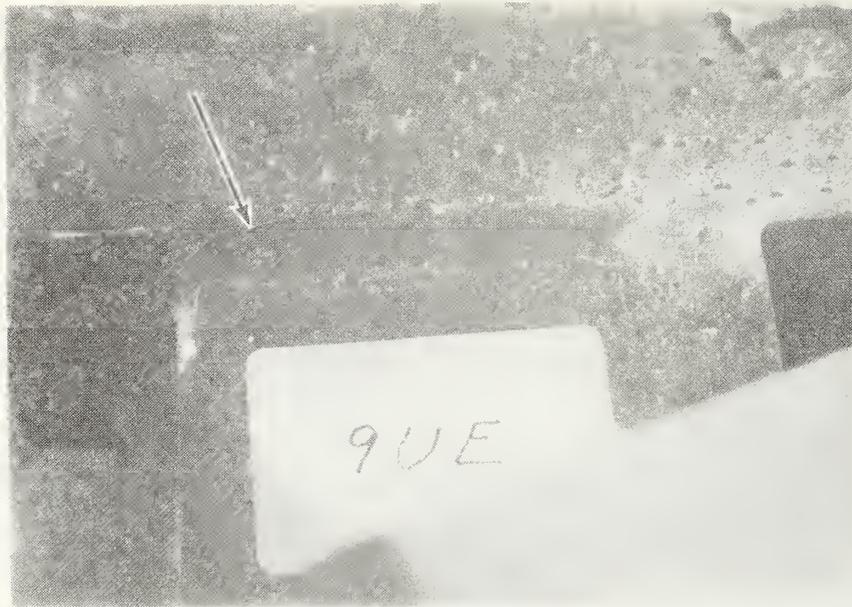
Figure 5.19 Incipient shear failure, bottom fillet weld of intact clip angle, location 9UE, south side.

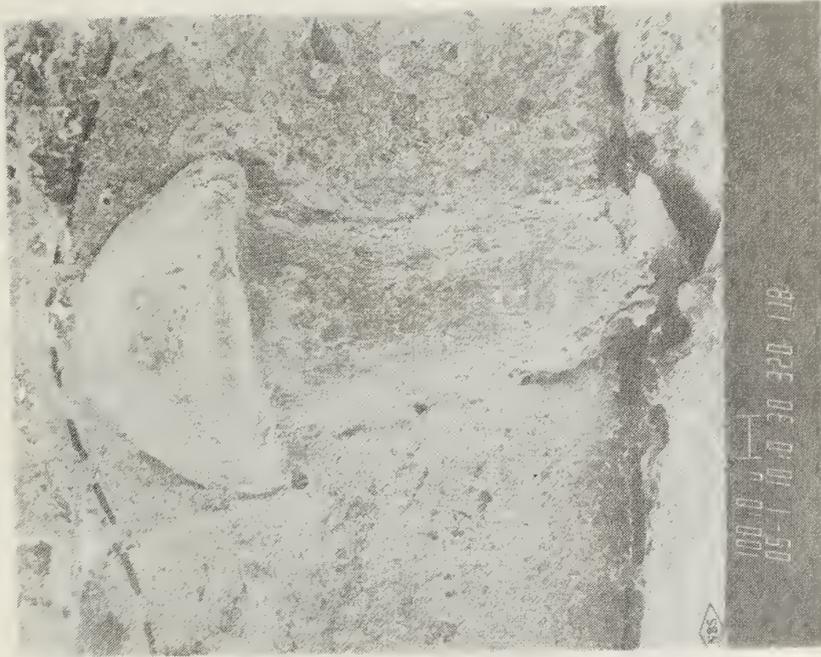
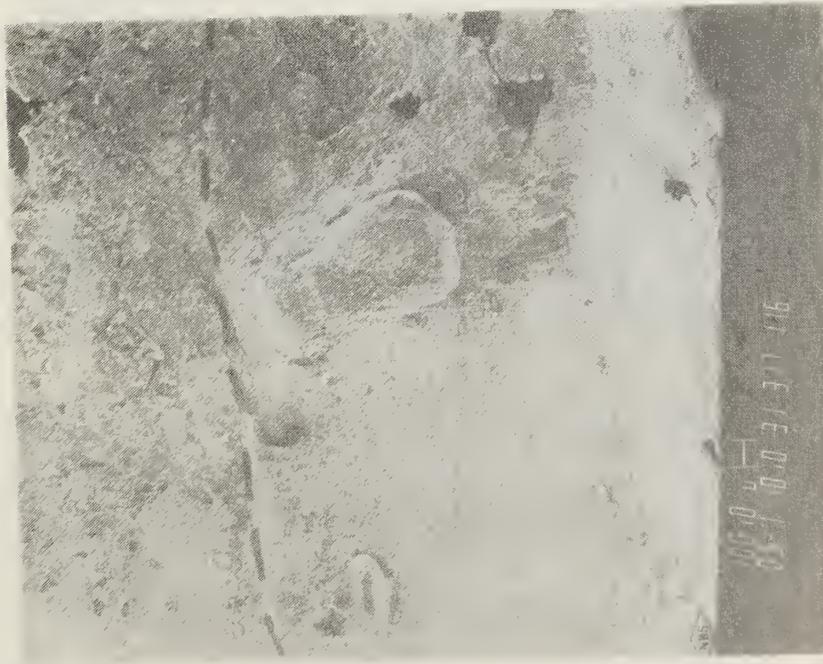
Figure 8.3 Photomicrographs showing that the crack initiated at the root of the weld and propagated to the exterior of the box beam (location 9UE). Figure (a) is located 3 mm from the end of the beam. Crack is propagating downward and slightly to the right. Figure (b) is located 18 mm from end of beam. Magnification (a) X30 and (b) X60.

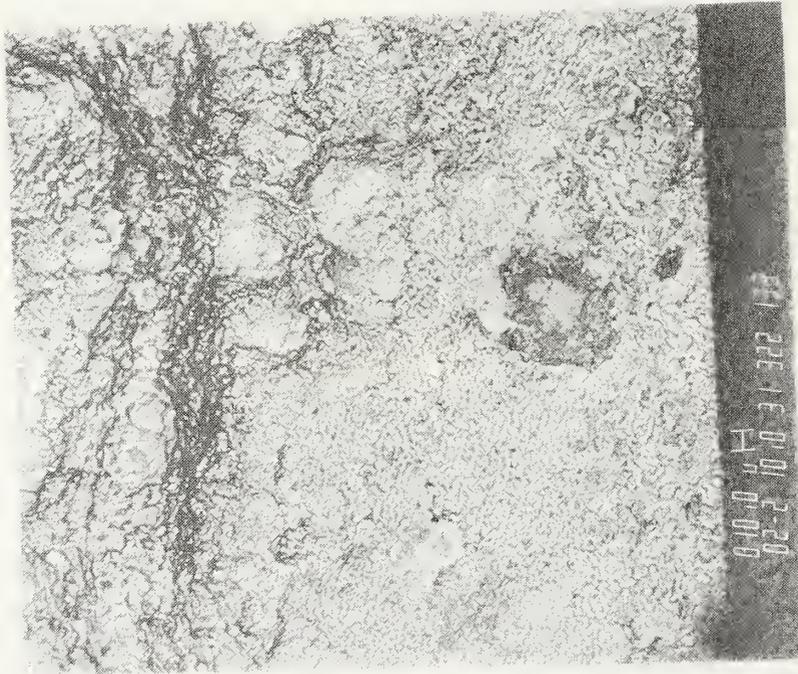
Figure 8.4 Photomicrograph of a replica from the shear lip region at location 8UE. The surface oxidation has removed the fine shear dimpled rupture features in this area. Magnification X250.

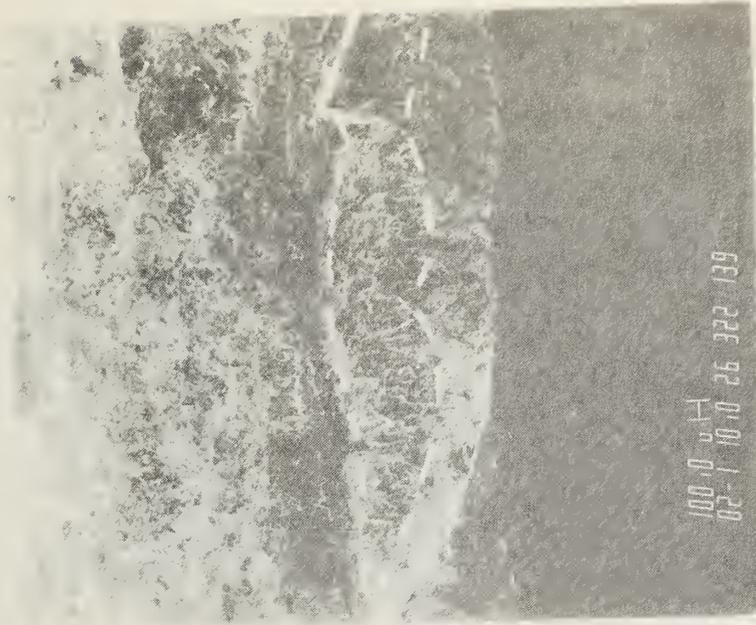
Figure 8.5 Fractographic evidence of preexisting cracks in walkway box beam exterior longitudinal welds at locations a) 9UW, b) 9UE, c) 8UW. Regions interpreted as cracks outlined by dashed lines. Magnifications X55, X250 and X25, respectively.

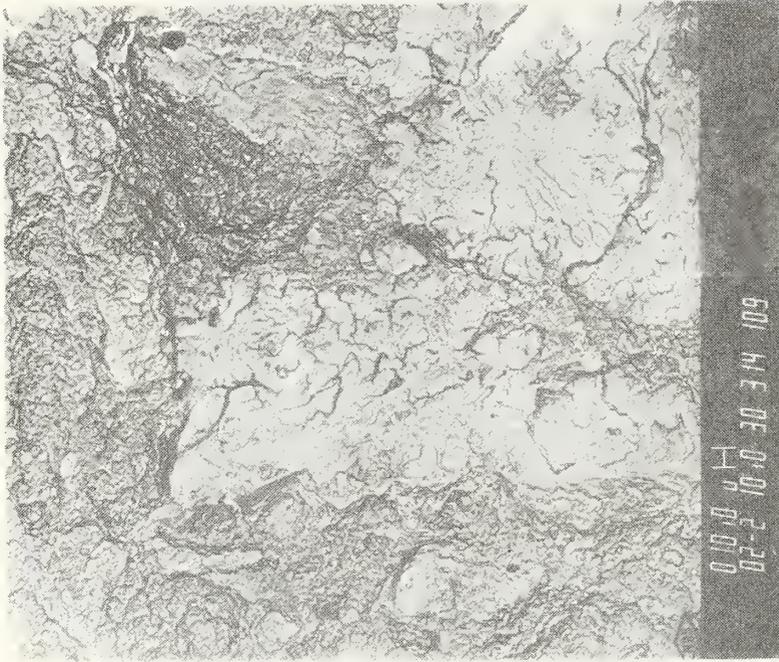
Figure 8.7 Cleavage facets observed at center line of lower exterior longitudinal weld at location 9UW (bright areas). Magnification X250.

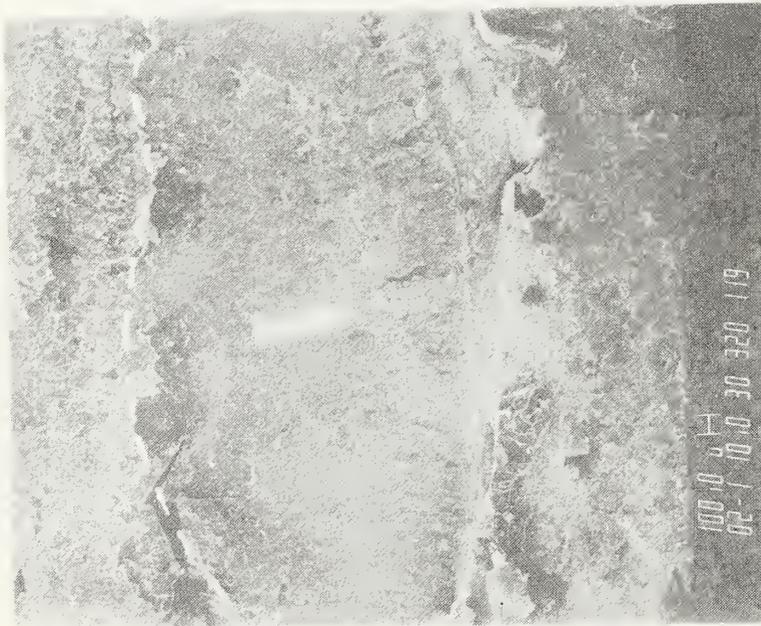
Figure 8.6 Evidence of fracture initiation from upper surface of interior tack weld (dashed line) at location 9UE. Direction of propagation is toward the weld root (arrow) normal to the welding direction. Magnification X25.

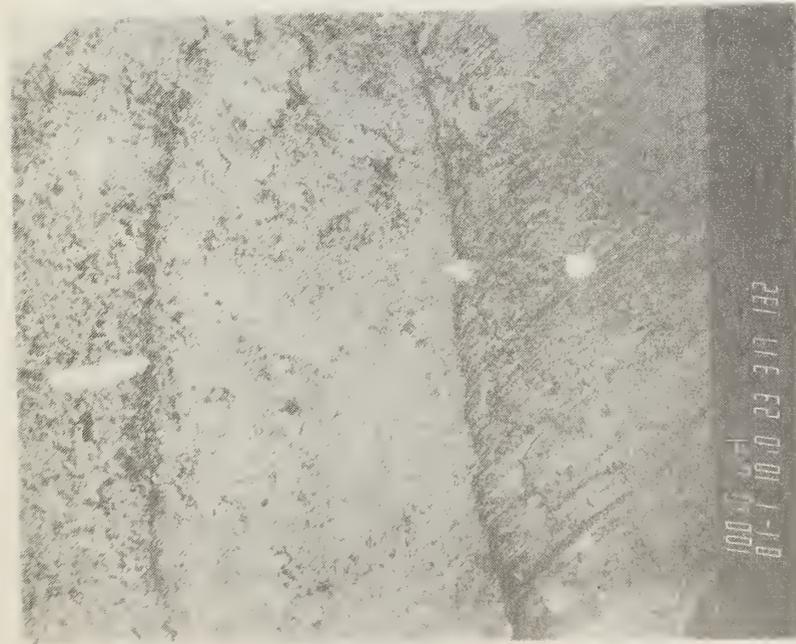
7. Two regions of washer imprints were observed on the bottom surfaces of the box beam flanges. The outermost region contains the imprint of the washer and shows shallow striations. Nearer the hanger rod hole, there was a transition to a more deeply abraded region. This region showed evidence that the failure proceeded in a slip-stick manner.

Figure 8.8 Abrasion pattern on bottom flange at location 9UE (north). Arrow denotes initial washer imprint. (A) denotes change in abrasion mechanism. (B) denotes a slip-stick region in progressive failure. Magnification X15.

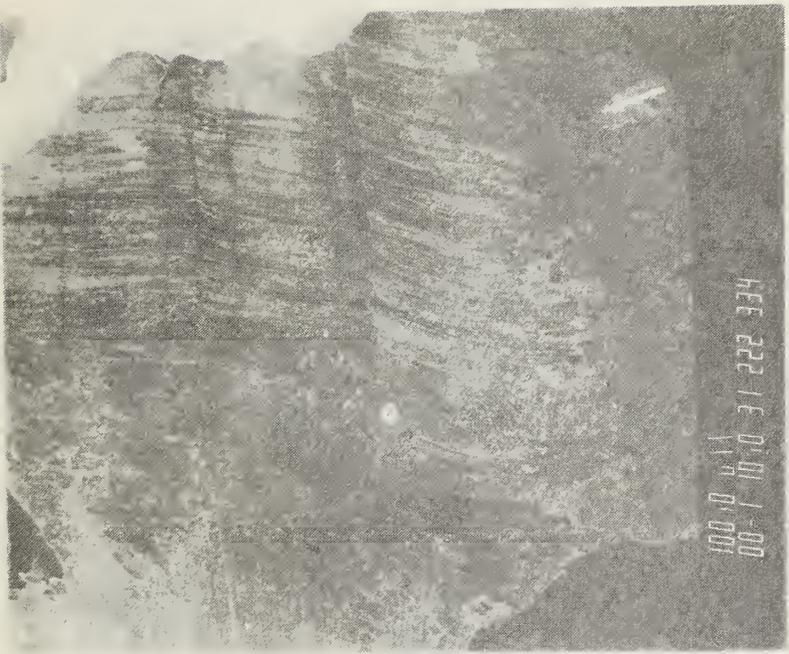
Figure 8.9 Abrasion pattern on bottom flange at location 10UE (south) showing multiple slip-stick regions. Arrow denotes initial washer contact. Magnification X15.

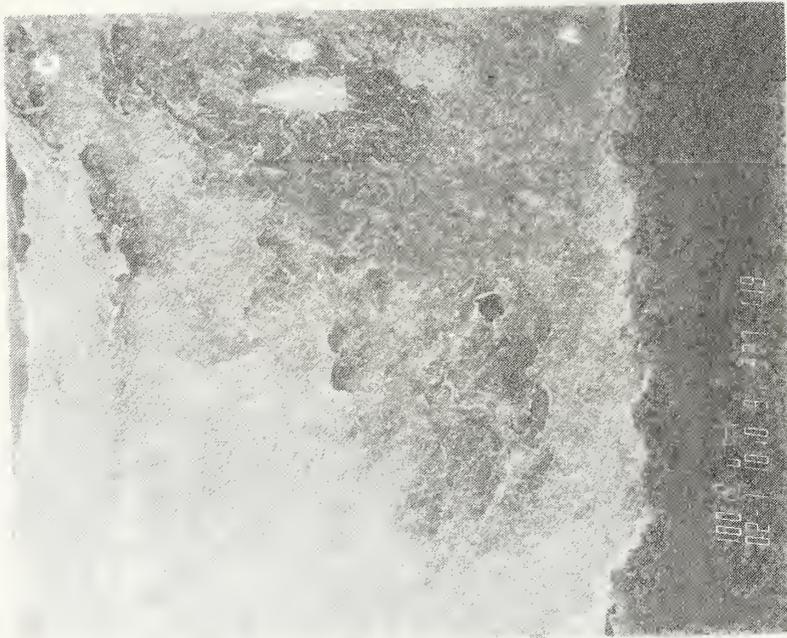
Figure 8.16 Fracture at top fillet weld at clip angle attachment, location 9UE (north). Initiation at A, propagation in direction B to shear lip at C. Magnification X25.
